Assessment of house at 90 Florida Road, Durban

Prepared for: Archipod
PO Box 37361
Overport
4067
November 2010

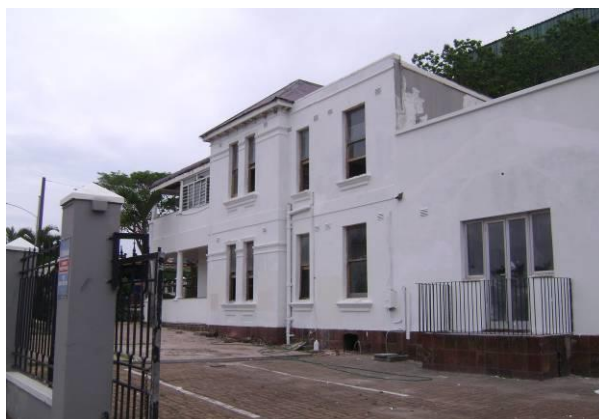
Figure 9: Showing balcony and aluminium doors to the south elevation

- The south elevation has a balcony and aluminium door (ca 1992)

RECOMMENDED ACTION It would be preferable if these could be removed and appropriate timber doors and windows be instated

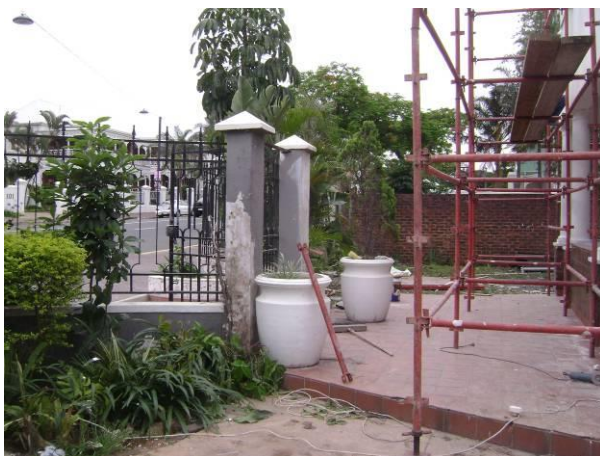
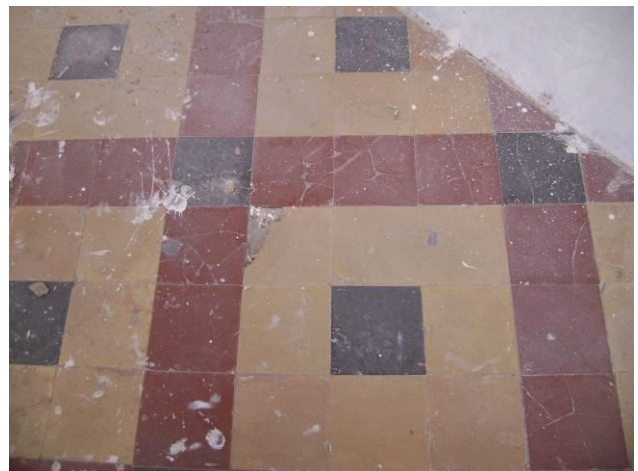
Figures 18 and 19: front garden and encaustic tile veranda- The balustrade wall on the front elevation is finished off on a level and has brown slate cladding to the outside.

- Encaustic tile floor to ground floor veranda. In good condition with some chipped tiles

RECOMMENDED ACTION: Retain as is.

RECOMMENDED ACTION: Remove slate and make good

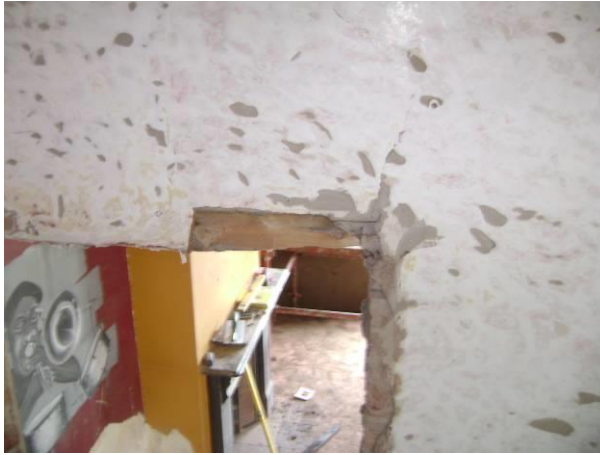
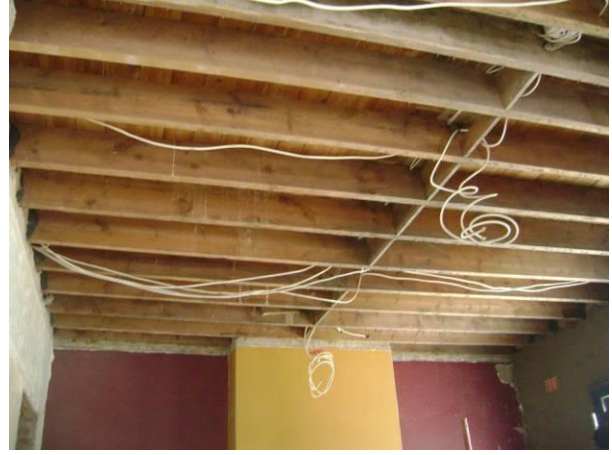
Figures 20 and 21: Entrance to Dining Room, lintel and architrave badly eaten by borer, the former removed, and ceiling in dining room showing removed strip timber ceiling.

- The strip Oregon pine ceilings have been removed as there has been a substantial amount of borer activity

RECOMMENDED ACTION: Replace ceilings and source extra boards (Amafa Materials bank)

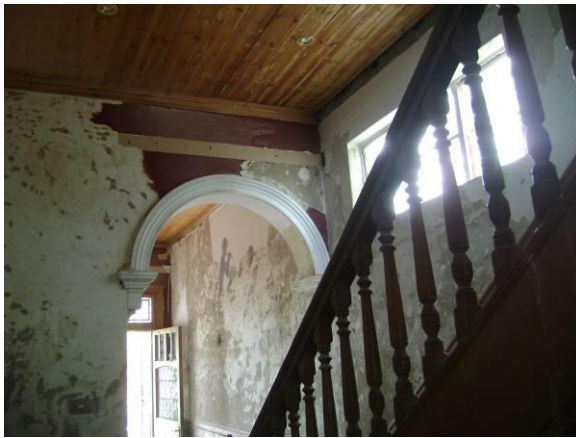
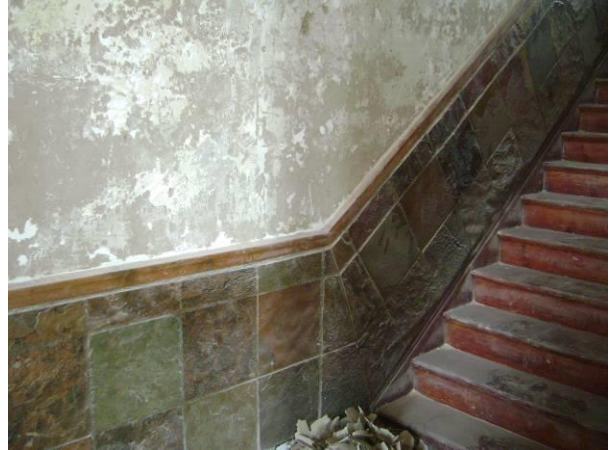
Figures 22 and 23: view back to front door, and stairway dado of brown slate cladding

- There is a brown slate dado outside, and in the entrance hall running up the stairs

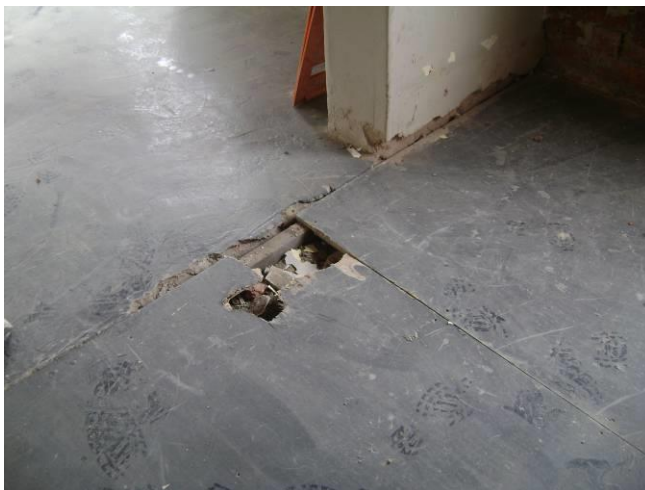
Fig 24: the marine plywood floor in the old pantry and Figure 25 the southern wall with friable plaster removed revealing quality of brickwork.

- The floor to what was previously the pantry is constructed of marine plywood.

RECOMMENDED ACTION: replace floor with suspended timber floor.

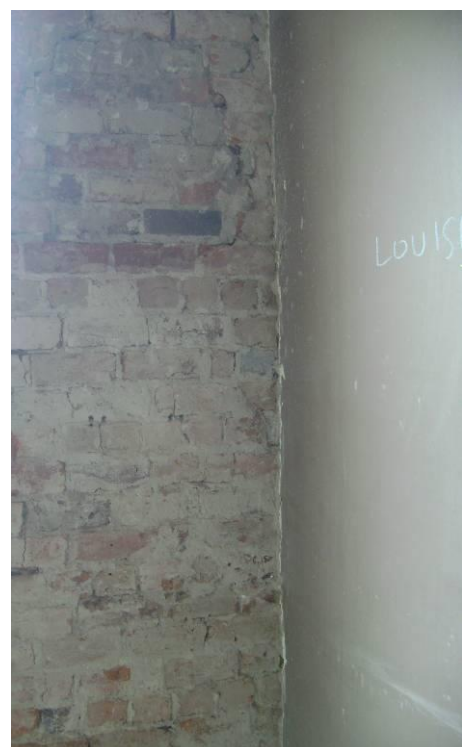
- The walls have had the plaster removed as the lime plaster the covered it was friable

RECOMMENDED ACTION: Replaster, preferably with a lime plaster

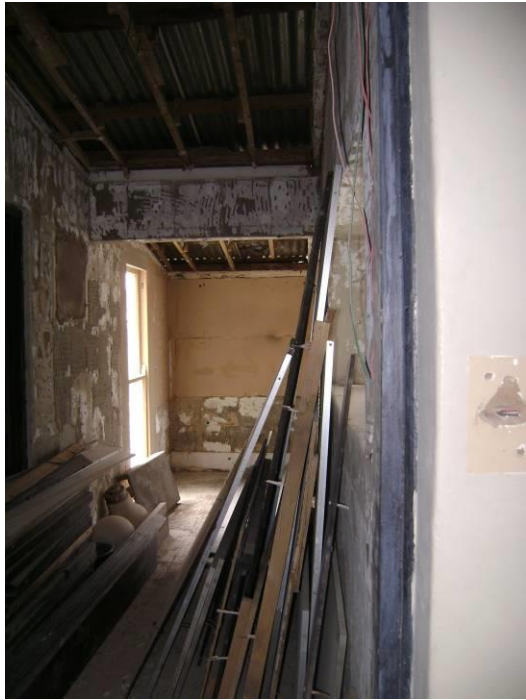
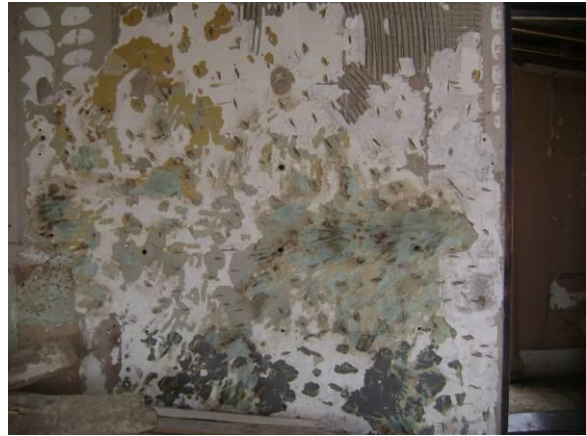
Figure 25: showing the storeroom, extant in the drawing prepared for Gilio in 1992, and in Figure 26 the layers of paint on the wall between the storeroom and what was recently used as a kitchen. Note that the paint is recent, as this wall/alteration is not part of the original plan of the house.

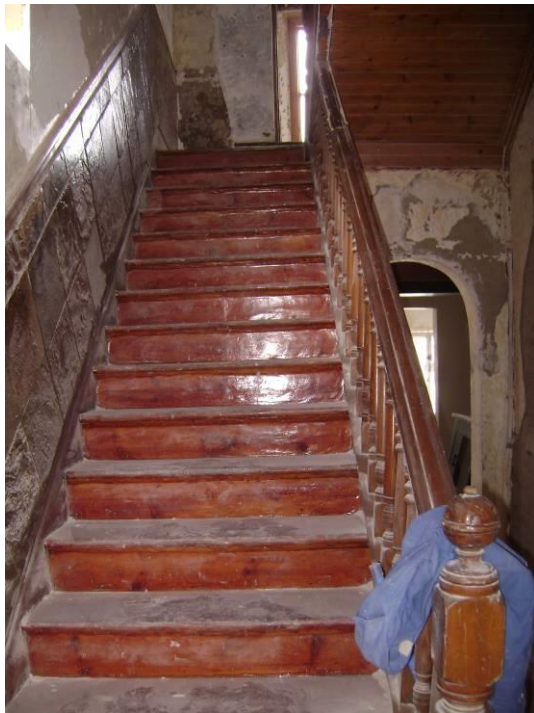
Figure 27: the staircase with original Newell post and the brown slate dado accretion to the supporting wall.

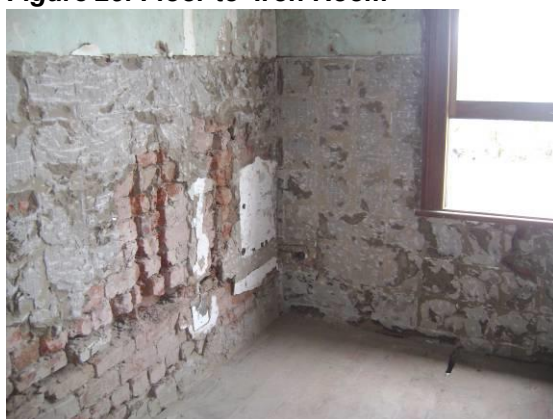
Figure 31: South bedroom showing wall construction

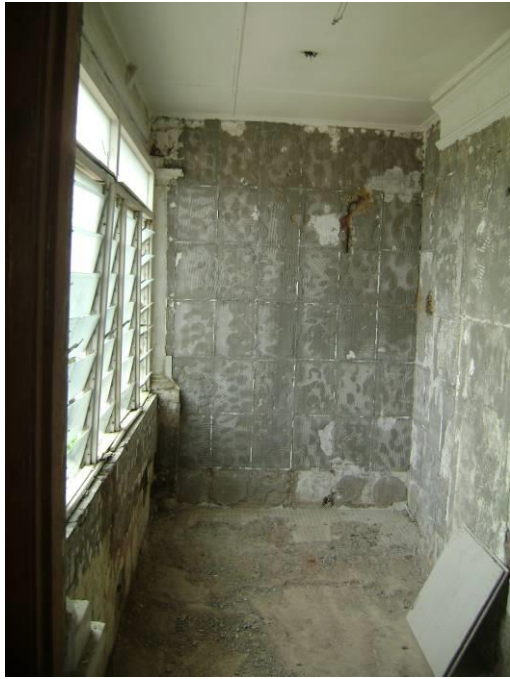
Figure 33: Enclosed bathroom on first floor possibly added by Gilio: veranda to be reinstated

- The first floor veranda has been partly enclosed (ca 1992)

RECOMMENDED ACTION: It would be preferable if this could be removed and the veranda reinstated

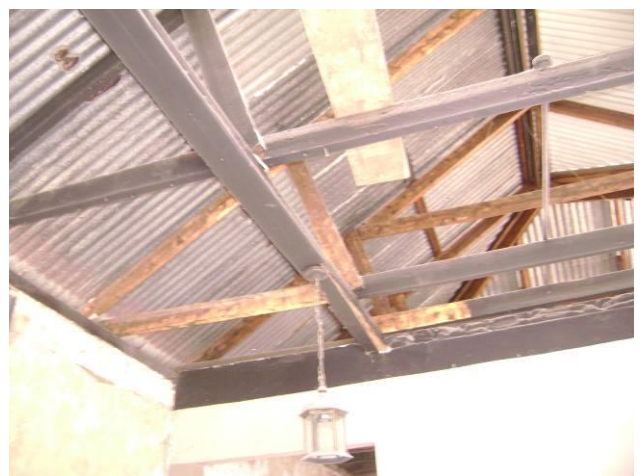
Figure 38: ceilings in west facing bedroom showing recent re-roofing

- The house was re-roofed, possibly in 1992. The intention is to re-roof the building again, using a Chromodek or Colomet to mimic the roofing of Quarters.

RECOMMENDED ACTION: the original sheeting is no longer on the roof, and has not been for many years. The author is of the opinion that this is an acceptable course of action.
